**(OPERATION OF A HAYNES ALLOY
NO. 25 FORCED CIRCULATION LOOP
TO STUDY THE EFFECTS OF HYDROGEN
IN A SIMULATED SUNFLOWER SYSTEM)**

by R. C. Schulze and D. B. Cooper

Prepared under Contract No. NAS 5-462 by
THOMPSON RAMO WOOLDRIDGE, INC.
Cleveland, Ohio

NASA CR-225

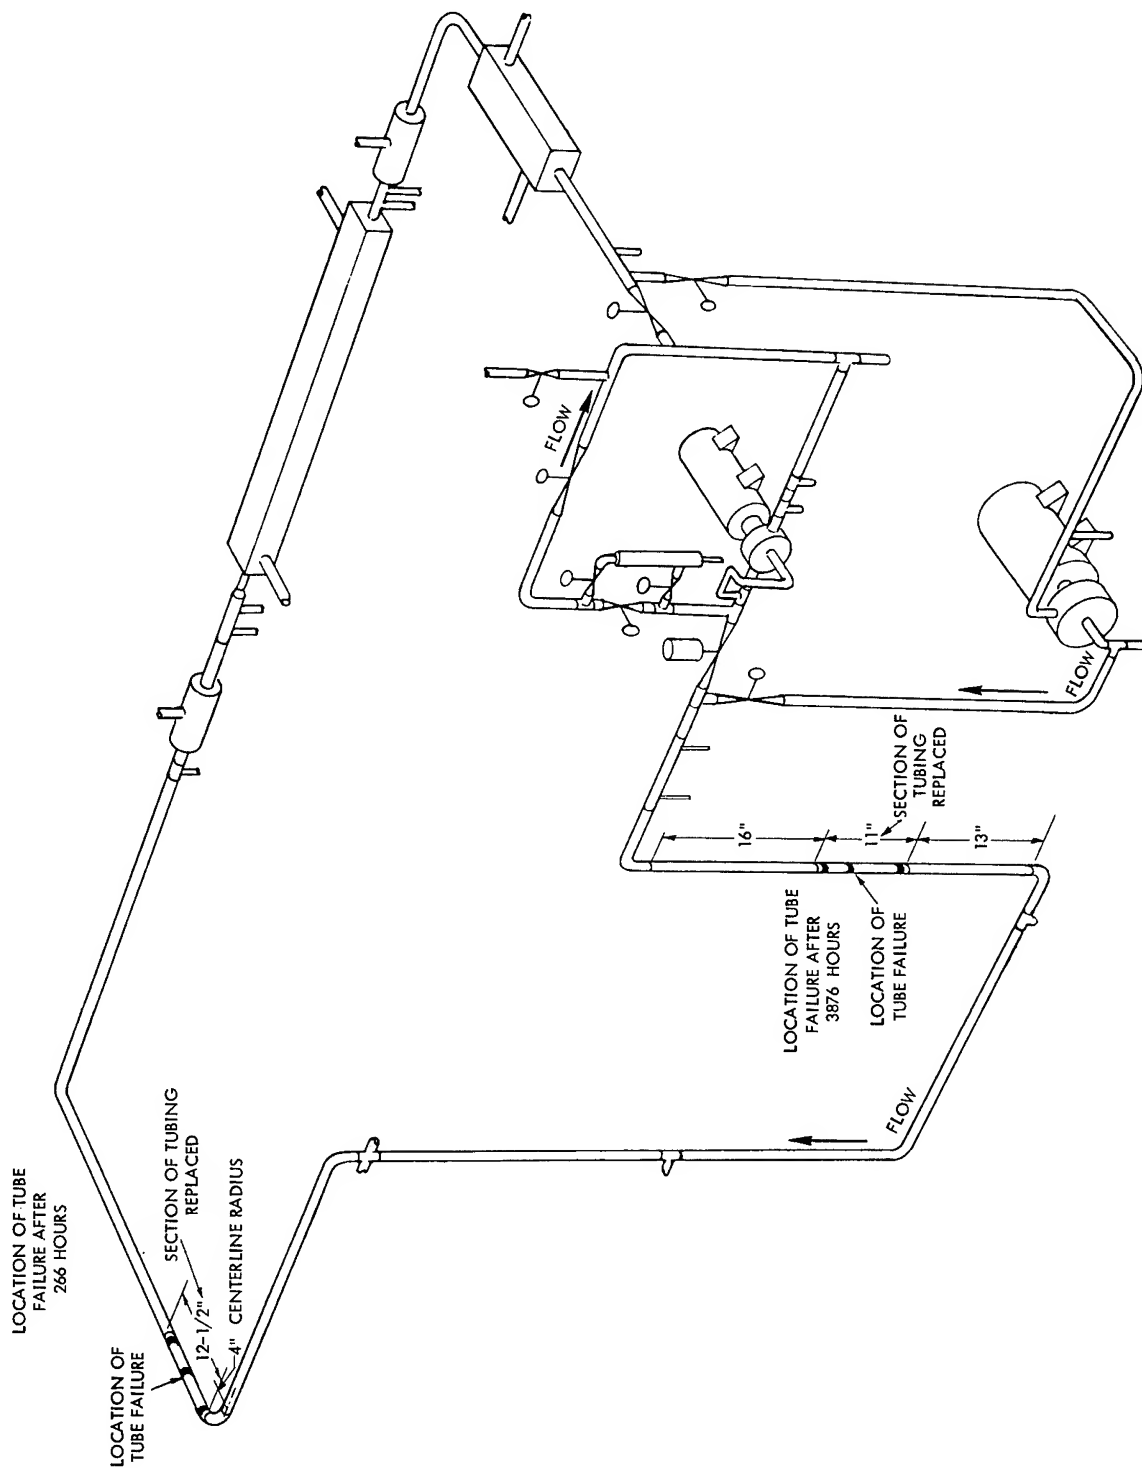
FIGURE 11 ISOMETRIC SKETCH OF THE LOOP SHOWING THE LOCATIONS OF THE TUBE FAILURES WHICH OCCURRED AFTER 266 AND 3876 HOURS

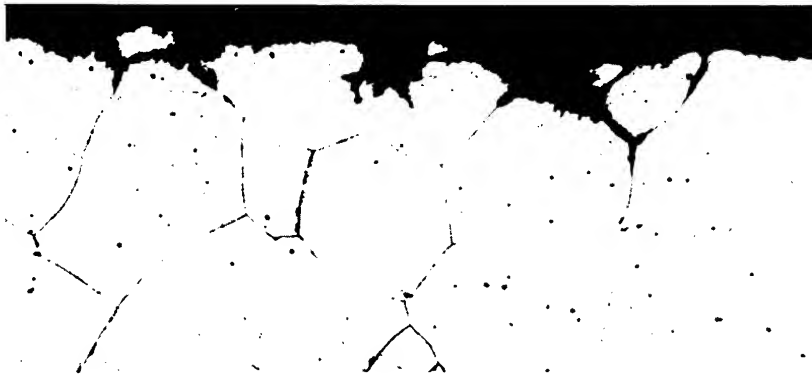
Figure 31. Appearance of Corrosive Attack Found on the I.D. Surface of the Specimen Removed from the Weld in the Lower Part of the Boiler Inlet (Section No. 11, Weld).

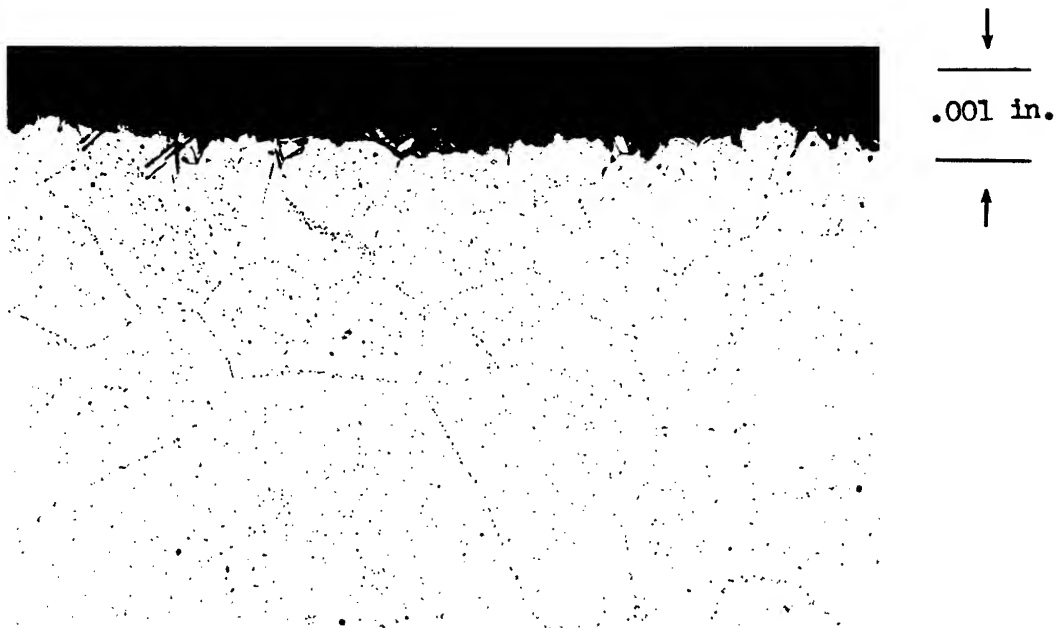
Figure 36. I.D. Surface of Specimen Removed from Superheater Inlet (Section No. 21, Thermocouple No. 20).

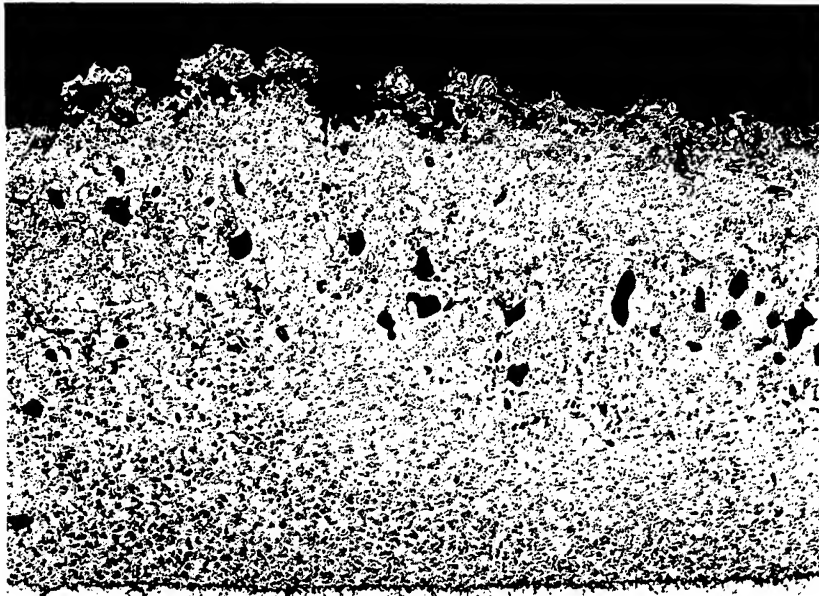
Figure 37. I.D. Surface of Specimen Removed from the Outlet Region of the Superheater (Section No. 26A, Thermocouple No. 24).

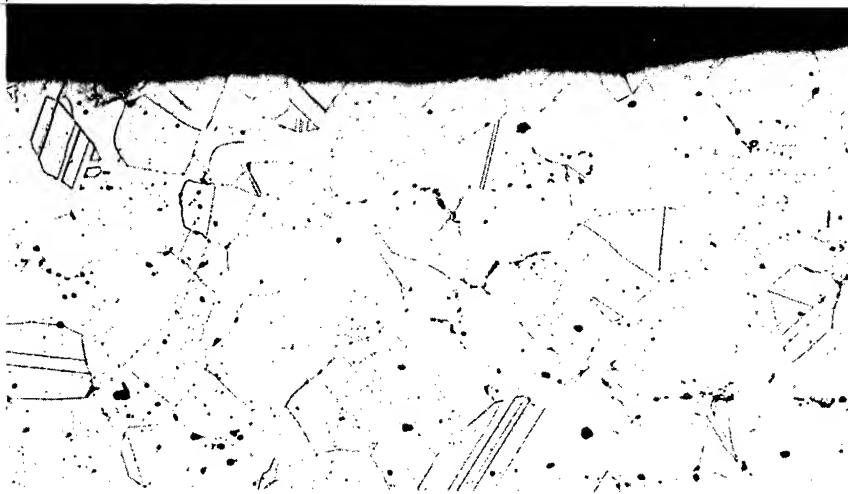
Figure 42. Appearance of Deposit Found on the I.D. Surface Near the Weld Area of the Specimen Removed from the Outlet Region of the Superheater (Section No. 25, Weld).

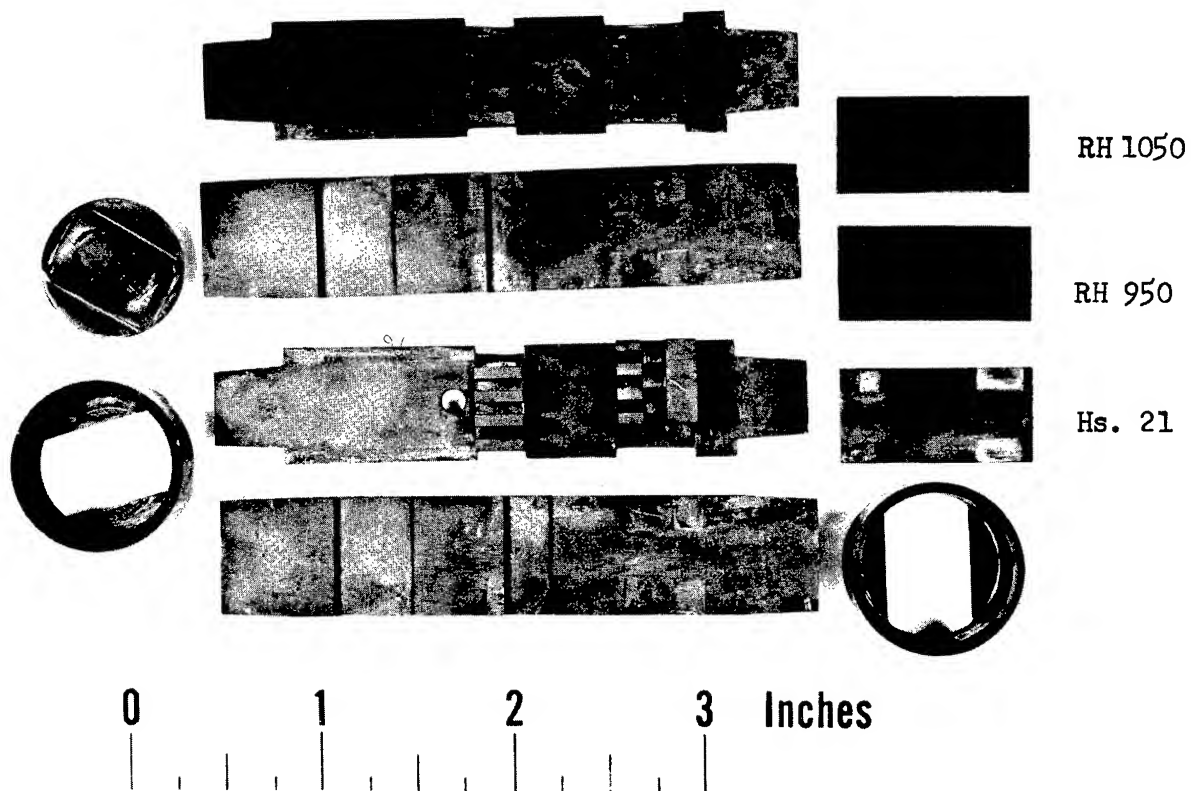
Figure 50. Appearance of Orifice and Specimen Holder Assembly After Test. Actual size.

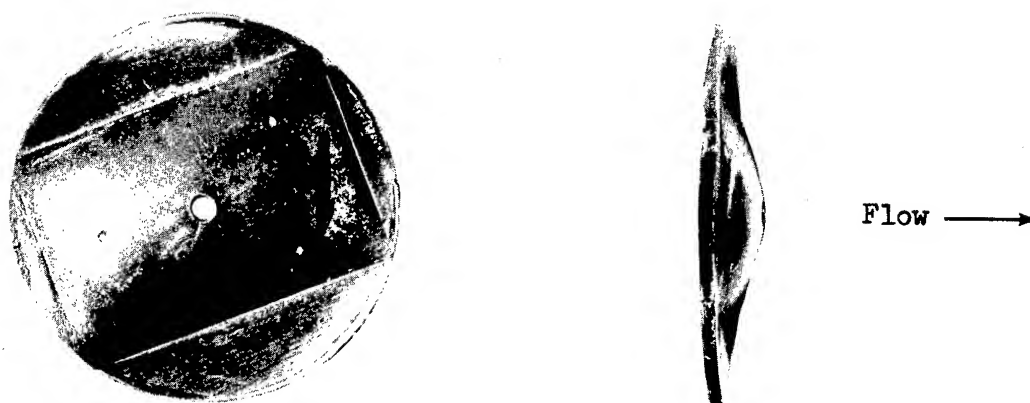
Figure 51. Macrograph of the Orifice Plate Showing the Amount of Distortion Incurred. Mag. 2.6X

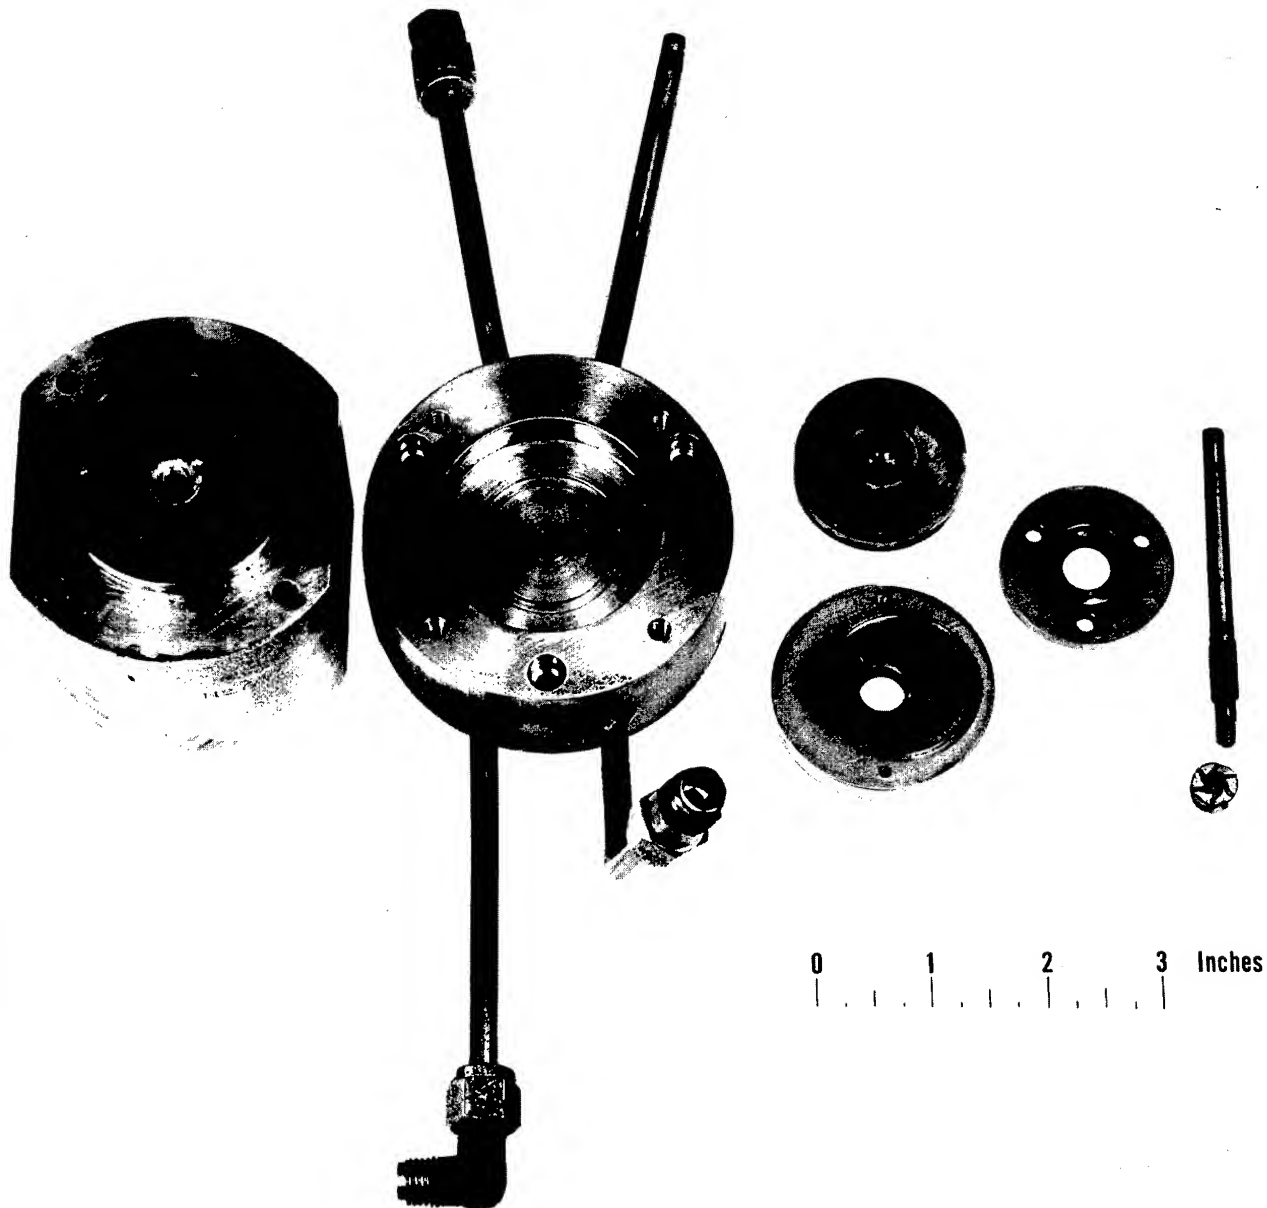
Figure 55. Condition of Centrifugal Pump Components After Test.
Size of components reduced to three-quarters original size.

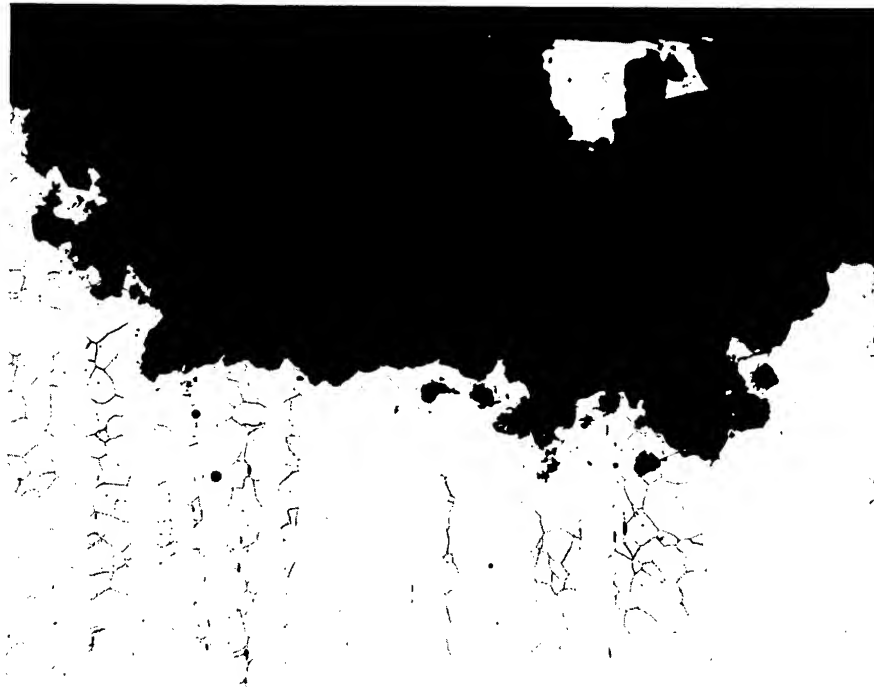
The centrifugal pump was operated for approximately 1000 hours, during these tests. The only area of the pump that was damaged during test was the volute tongue where an erosive action had occurred.

Figure 57. Appearance of the Damage Incurred Around the Volute Tongue. Specimen removed from the top half of the pump body which was fabricated from Type 316 Stainless Steel.

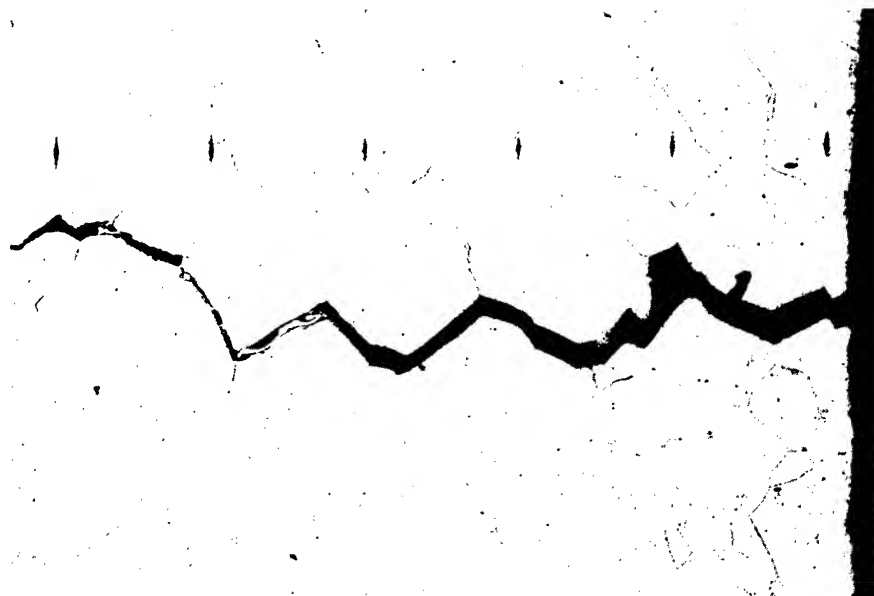
Figure 59. Appearance of the Crack Found in the Tube Wall of the Superheater After 262 Hours of Operation.

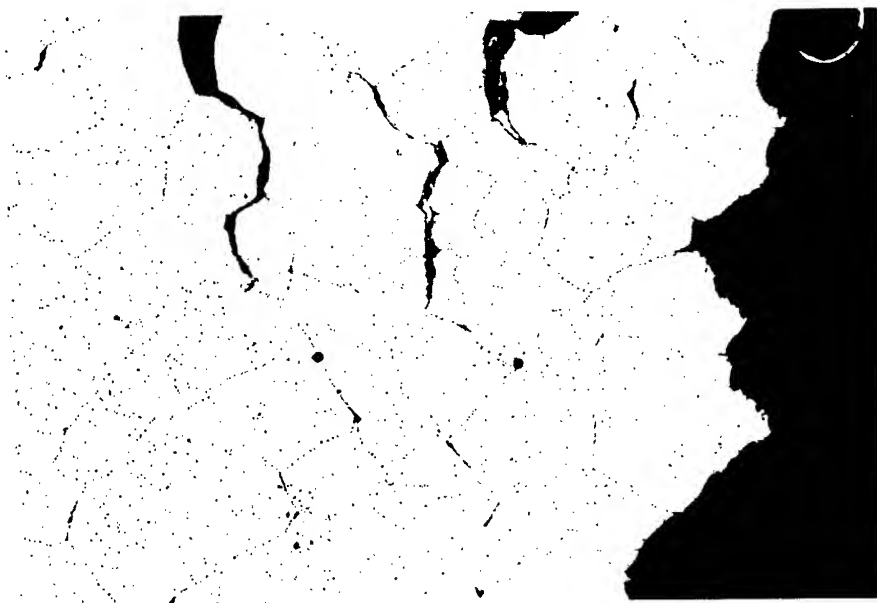
Figure 61. Appearance of the Tube Wall of the Boiler Showing the Failure which Occurred After 3876 Hours.

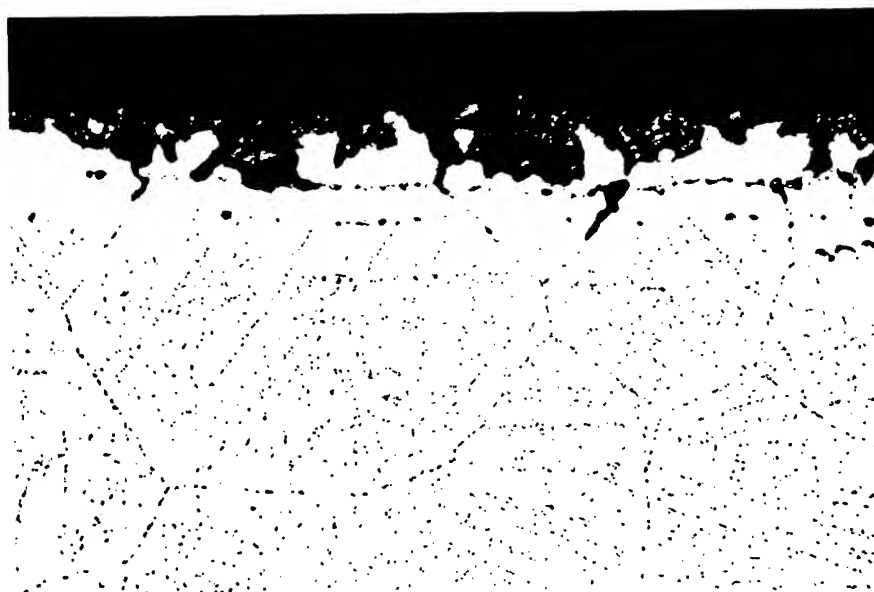
Figure 62. Appearance of the I.D. Surface Near the Failure which Occurred in the Boiler After 3876 Hours.
